# GEOTECHNICAL DESIGN REPORT BEACH LOOP SUBDIVISION T28S, R15W, SEC 36C TAX LOTS 219, 400, 500, 600, 700 & 1500 BEACH LOOP ROAD BANDON, OREGON

By: THE GALLI GROUP 612 NW Third Street Grants Pass, OR 97526 (541) 955-1611

> 02-6151-02 October 18, 2022

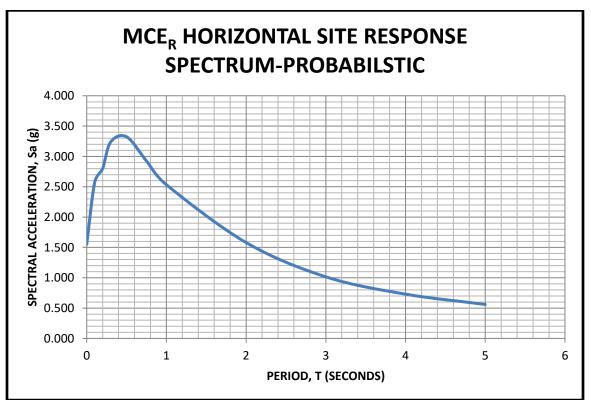
Diagram 1. Site specific MCE<sub>R</sub> spectral accelerations from the probabilistic ground motion hazard analysis.

The probabilistic ground motion hazard analysis was accomplished consistent with method 1 in the ASCE 7-16 Section 21.2.1.1. We utilized the US Geologic Survey (USGS, 2014) Unified Hazard Tool to compute the Uniform Hazard Response Spectrum that has a 2% probability of exceedance within a 50-year period for the site. The site Risk Coefficients,  $C_{Rs}$  and  $C_{R1}$  were obtained from Figures 22-18 and 22-19, respectively, of the ASCE 7-16. The  $C_R$  was then calculated as described in the Section 21.2.1.1. The scale factor recommended in Section 21.2 was introduced to scale the response spectrum to the maximum response. The probabilistic site specific MCE<sub>R</sub> at any period was determined as the product of the Uniform Hazard Response Spectrum, the  $C_R$  and the scale factor at that period. The site specific MCE<sub>R</sub> spectral accelerations from the probabilistic ground motion hazard analysis are shown in Diagram 1 (following).

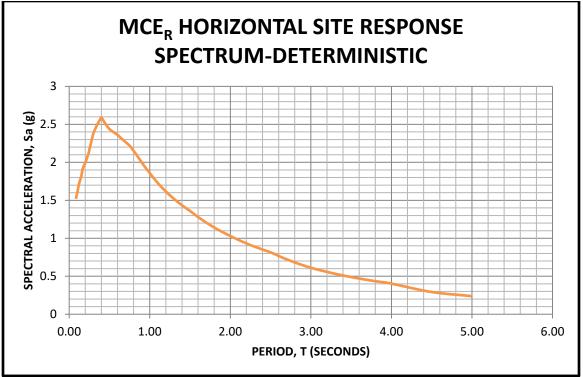
Diagram 2. Site specific MCE<sub>R</sub> spectral accelerations from the Deterministic ground motion hazard analysis.

Six ground motion prediction equations developed for Cascadian Subduction and Interface fault systems were used to calculate the 5% damped Horizontal Spectral Acceleration for the site. The deterministic MCE<sub>R</sub> was determined as the geometric mean of the calculated spectral response accelerations at the 84th percentile. The following prediction equations were used; (Atkinson and Macias 2009), Atkinson & Boore, 2003, BC Hydro, (2016), BC Hydro, (2018), Montalva et al., (2017), (Grego, et al. 2002). The source-to-site distance of 50km and a moment magnitude Mw=9.0 were used in the equations. The site specific MCE<sub>R</sub> spectral accelerations from the deterministic ground motion hazard analysis are given in Diagram 2.

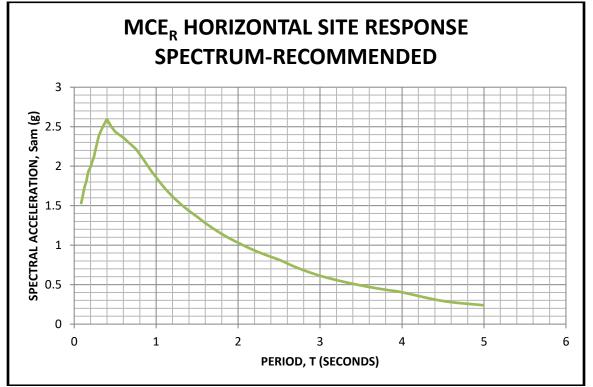
Diagram 3. Recommended MCE<sub>R</sub> Response Spectrum from the Site-Specific Ground Motion Hazard Analysis

The Site Specific MCE<sub>R</sub> spectral response acceleration at any period,  $S_{am}$ , is taken as the lesser of the spectral response accelerations from the probabilistic ground motion hazard analysis and the deterministic ground motion hazard analysis, according to Section 21.2.3 of ASCE 7-16. The recommended site specific MCE<sub>R</sub> is given in Diagram 3 (on the following page).

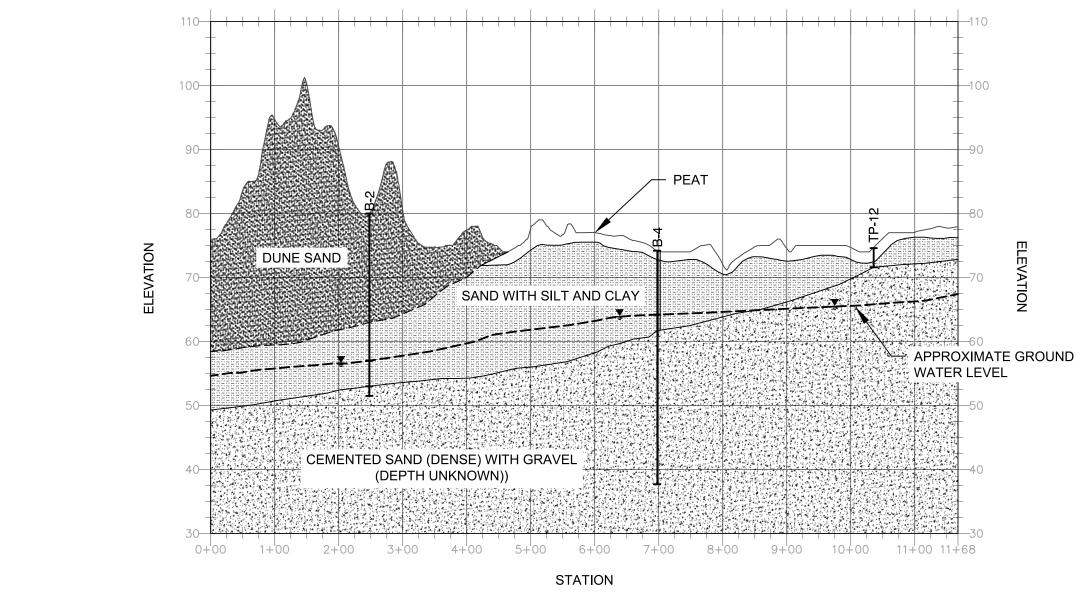
# **CROSS SECTION B-B'**

HORIZONTAL SCALE IN FEET 10X VERTICAL SCALE

նլ	THE GALLI GROUP geotechnical consulting	CROSS SECTION B-B'	DATE: OCTOBER 2022 JOB NO: 02-6151-02 REV: 10/17/2022 4:07 PM	
-	612 NW 3rd Street Grants Pass, OR 97526	BANDON OBECON	PREPARED BY: BD 6151 Beach Loop - 3A 3B - Cross-sections.dwg	38

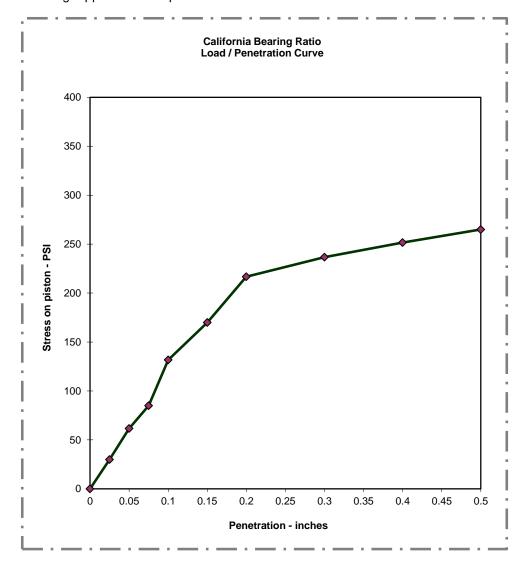
#### CBR Value: 13 EQUIVALENT TO R-VALUE = 44

Compacted utilizing ASTM D698	8 (Standard Proctor) methods
Tested Dry Density:	103.4 pcf (@ 97% of Maximum Dry Density, est.)
M/C:	19.7 % (existing)
Surcharge on sample:	12.6 pounds
Sample soaked:	112.5 hours
Swell:	0.0 %
Average moisture of sample after	er soaking: 18.8%
Moisture after soaking- upper 1"	of sample: 17.6%

California Bearing Ratio (CBR) ASTM D1883

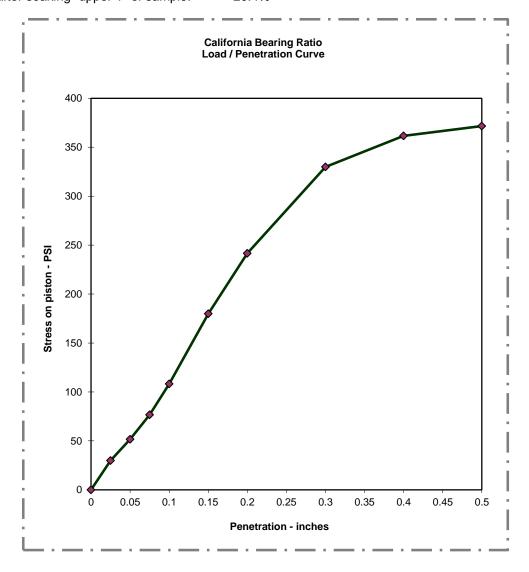
#### CBR Value: 11 EQUIVALENT TO **<u>R-VALUE = 40</u>**

Compacted utilizing ASTM D698	3 (Standard Proctor) methods	
Tested Dry Density:	116.1 pcf (@ 95% of Maximum Dry Density, est.)	ļ
M/C:	7.0 % (existing)	
Surcharge on sample:	12.6 pounds	
Sample soaked:	81 hours	
Swell:	0.0 %	
Average moisture of sample afte	er soaking: 20.5%	
Moisture after soaking- upper 1"	of sample: 20.4%

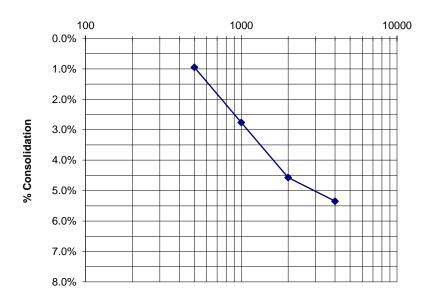
#### Percent Consolidation

Sulting Client: Bandon Beach Ventures, LLC Project: Beach Loop Rd. Date: 9/15/2022 Method of Test: ASTM D2435, Method A Job No: 02-6151-02 Location: TP-3 @ 5.2' Sample Date: 9/9/2022 Description of Soil: dark brown, silty Sand

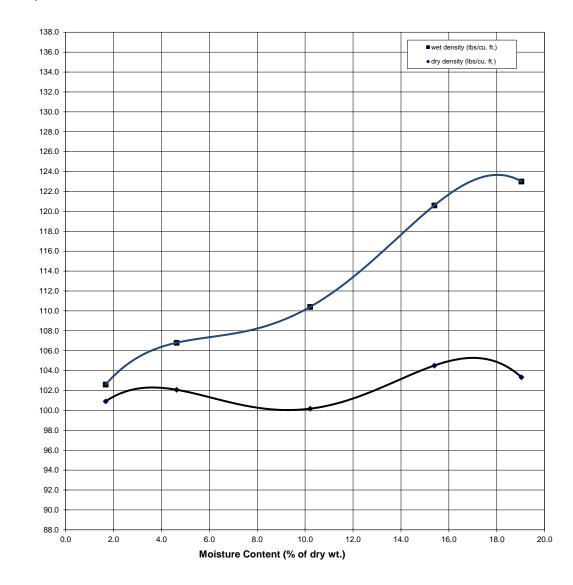
Client: Parametrix Project: Beach Loop Rd. Job No: 02-6151-02 Date of Test 9/12/2022 Method of Test: ASTM D-698 A Visual Classification: Light Brown Sand Sample Date: 9/9/2022 Sample Location: TP 4 4'-6'

# Maximum Dry Density (PCF):105.1Optimum Moisture Content:17.3%

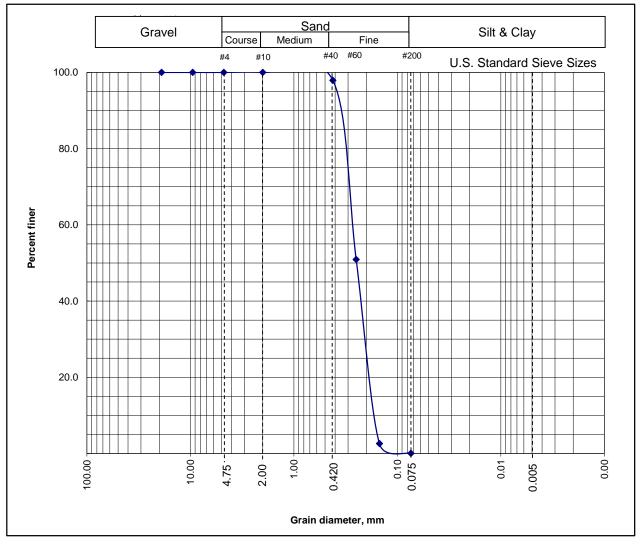
Client: Bandon Beach Ventures, LLC Project: Beach Loop Rd. Job No: 02-6151-02 Date Tested: 9/1/2022 Date Sampled: 8/29/2022 Description of Soil: Sand Sample Location: B-1/S-2 Depth of Sample: 5.0' - 6.5'

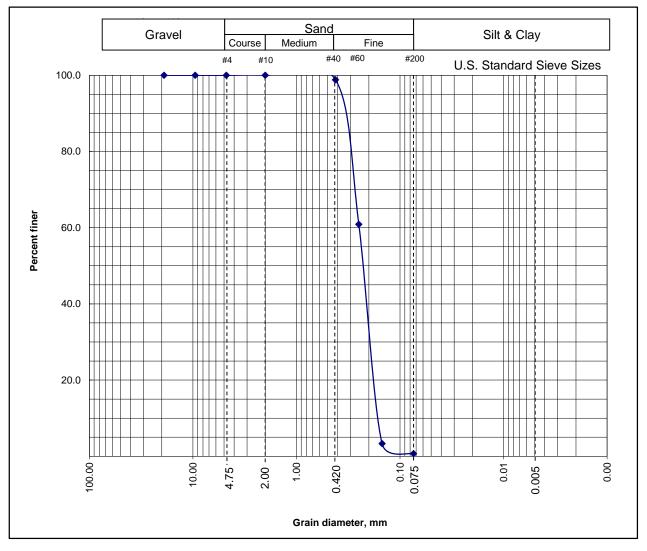
Client: Bandon Beach Ventures, LLC Project: Beach Loop Rd. Job No: 02-6151-02 Date Tested: 9/1/2022 Date Sampled: 8/29/2022 Description of Soil: Sand Sample Location: B-2/S-4 Depth of Sample: 10.0' - 11.5'

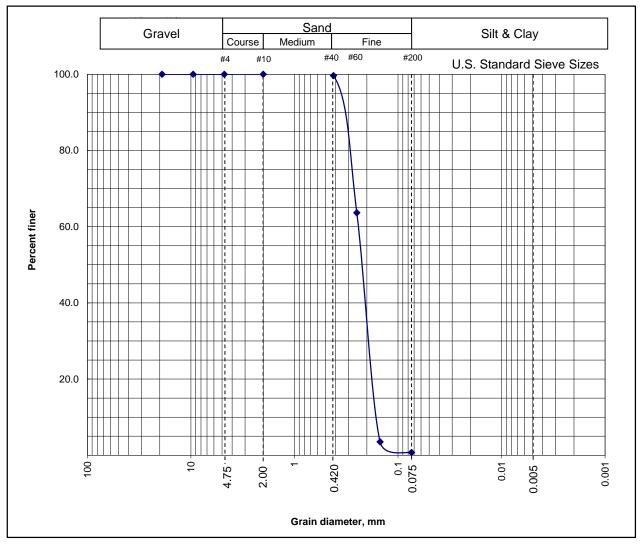
Client: Bandon Beach Ventures, LLC Project: Beach Loop Rd. Job No: 02-6151-02 Date Tested: 9/1/2022 Date Sampled: 8/29/2022 Description of Soil: Sand Boring No / Sample No: B-2/S-6 Depth of Sample: 15.0' - 16.5'

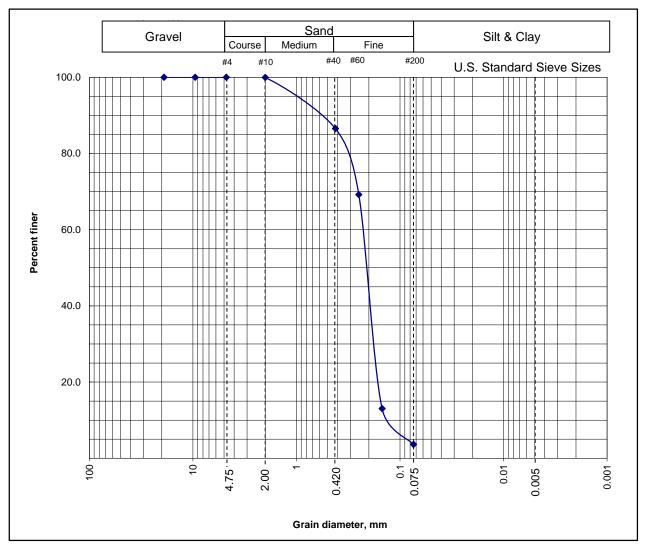
Client: Bandon Beach Ventures, LLC Project: Beach Loop Rd. Job No: 02-6151-02 Date Tested: 9/1/2022 Date Sampled: 8/29/2022 Description of Soil: Sand Boring No / Sample No: B-2/S-9 Depth of Sample: 30.0' - 31.5'

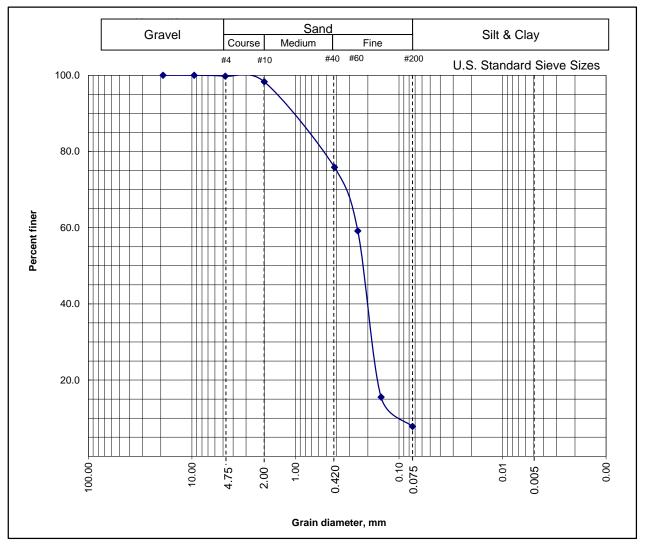
Client: Bandon Beach Ventures, LLC Project: Beach Loop Rd. Job No: 02-6151-02 Date Tested: 9/1/2022 Date Sampled: 8/29/2022 Description of Soil: Sand, trace silt and clay Sample Location: B-4/S-2 Depth of Sample: 5.0' - 6.5'

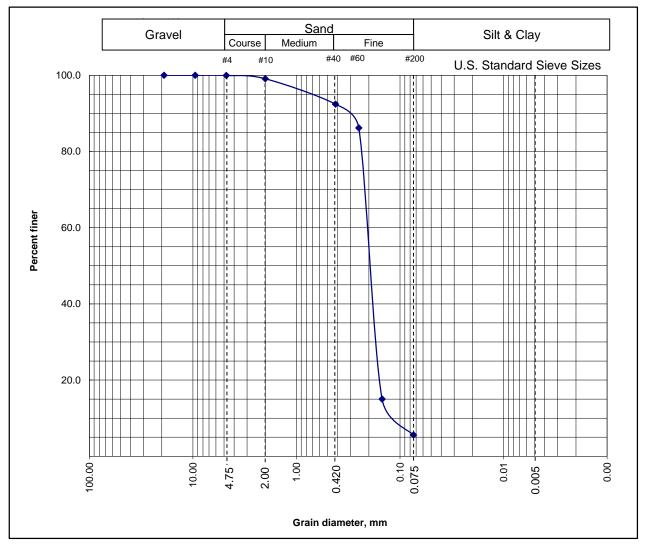
Client: Bandon Beach Ventures, LLC Project: Beach Loop Rd. Job No: 02-6151-02 Date Tested: 9/1/2022 Date Sampled: 8/29/2022 Description of Soil: Sand Sample Location: B-4/S-4 Depth of Sample: 10.0' - 11.5'

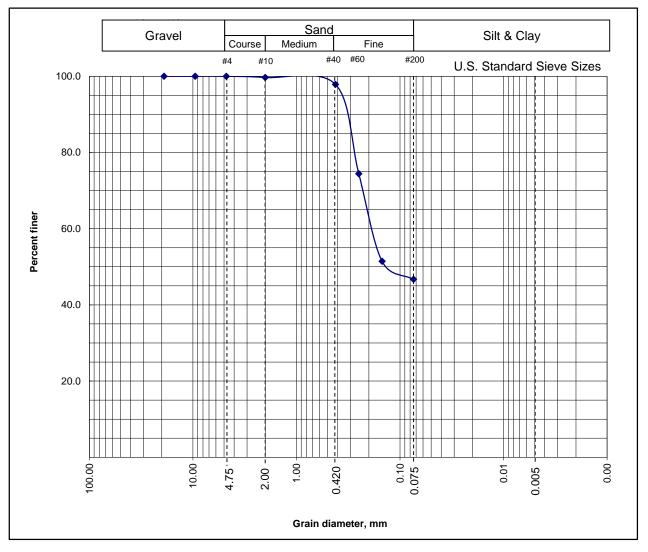
Client: Bandon Beach Ventures, LLC Project: Beach Loop Rd. Job No: 02-6151-02 Date Tested: 9/12/2022 Date Sampled: 9/9/2022 Description of Soil: silty, clayey Sand Sample Location: TP-5/S-1 Depth of Sample: 2.0'-3.0'

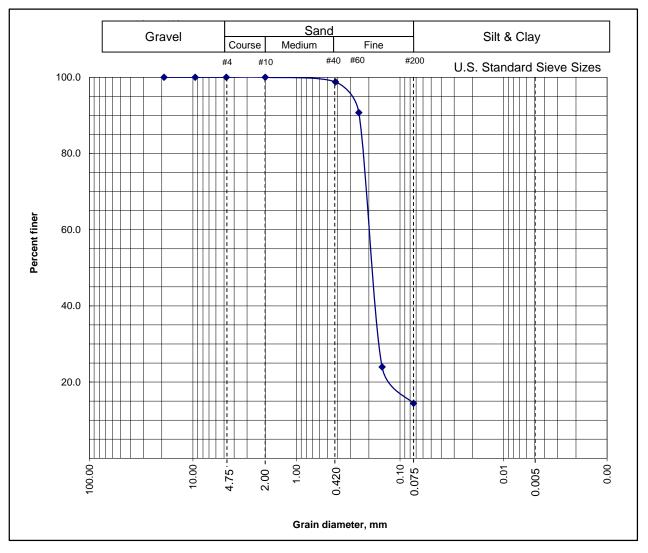
Client: Bandon Beach Ventures, LLC Project: Beach Loop Rd. Job No: 02-6151-02 Date Tested: 9/12/2022 Date Sampled: 9/9/2022 Description of Soil: Sand, with silt and clay Sample Location: TP-5/S-2 Depth of Sample: 5.5' - 6.0'

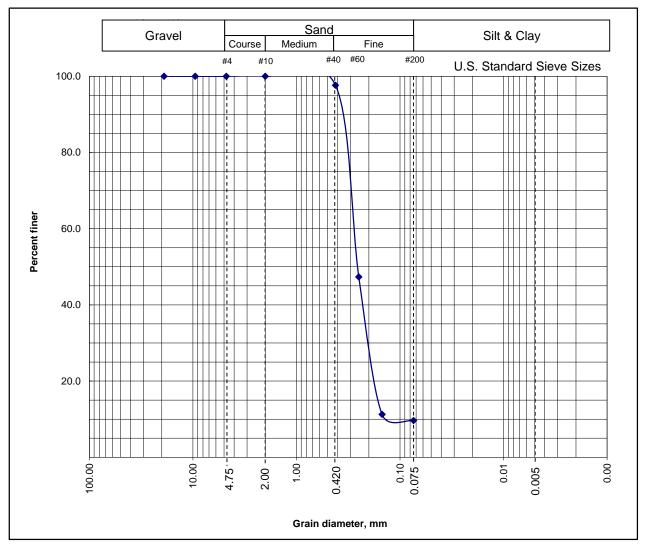
Client: Bandon Beach Ventures, LLC Project: Beach Loop Rd. Job No: 02-6151-02 Date Tested: 9/12/2022 Date Sampled: 9/9/2022 Description of Soil: Sand, trace silt and clay Sample Location: TP-6/S-1 Depth of Sample: 2.0' - 3.5'

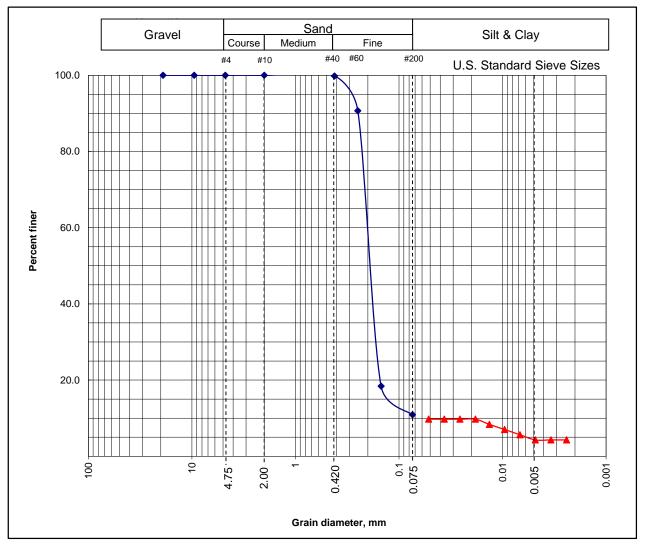
Client: Bandon Beach Ventures, LLC Project: Beach Loop Rd. Job No: 02-6151-02 Date Tested: 9/1/2022 Date Sampled: 8/29/2022 Description of Soil: Sand, trace silt and clay Boring No / Sample No: B-1/S-4 Depth of Sample: 10.0' - 11.5'

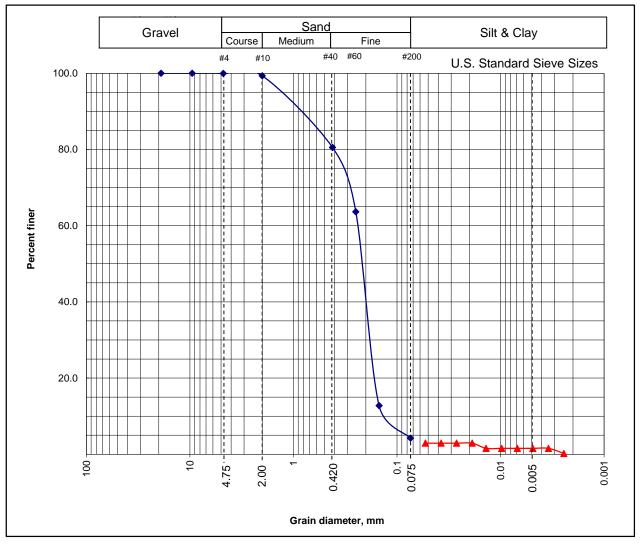
Client: Bandon Beach Ventures, LLC Project: Beach Loop Rd. Job No: 02-6151-02 Date Tested: 9/1/2022 Date Sampled: 8/29/2022 Description of Soil: Sand Boring No / Sample No: B-3/S-2 Depth of Sample: 5.0' - 6.5'

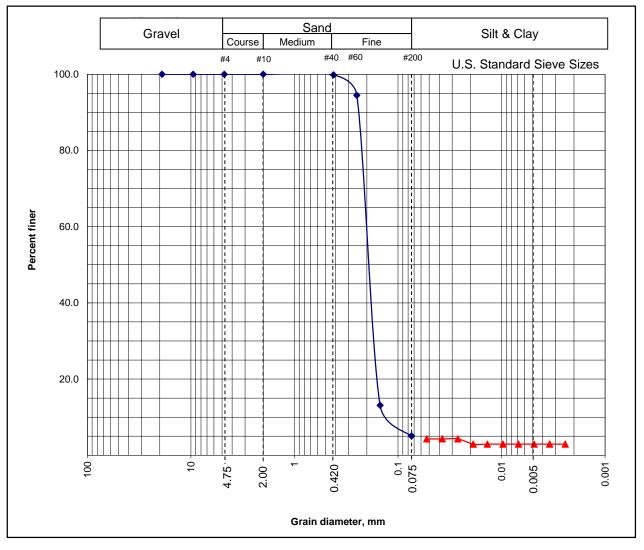
Client: Bandon Beach Ventures, LLC Project: Beach Loop Rd. Job No: 6151-02 Date Tested: 9/1/2022 Date Sampled: 8/29/2022 Description of Soil: Sand Boring No / Sample No: B-3/S-4 Depth of Sample: 10.0' - 11.5'

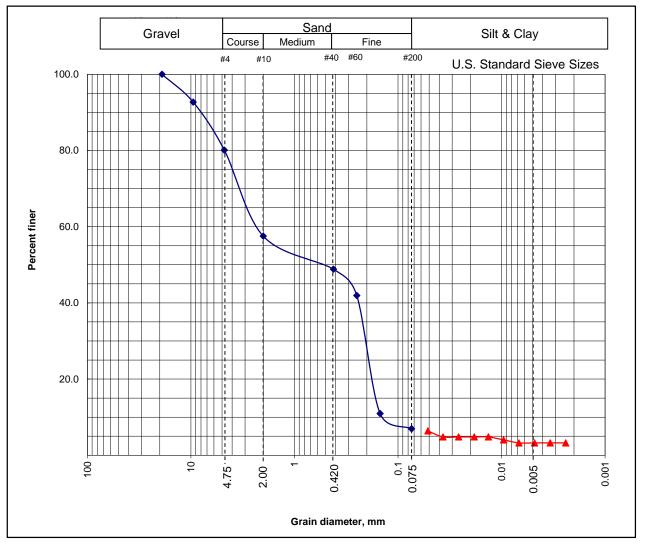
Client: Bandon Beach Ventures, LLC Project: Beach Loop Rd. Job No: 02-6151-02 Date Tested: 9/1/2022 Date Sampled: 8/29/2022 Description of Soil: gravelly Sand Boring No / Sample No: B-3/S-6 Depth of Sample: 15.0' - 16.5'
